# BARR COLONY SCHOOL **FEASIBILITY REPORT**

November 2023

## Summary of Mould Assessment Report Findings

### **Exploration of the perimeter detail (typical throughout)**

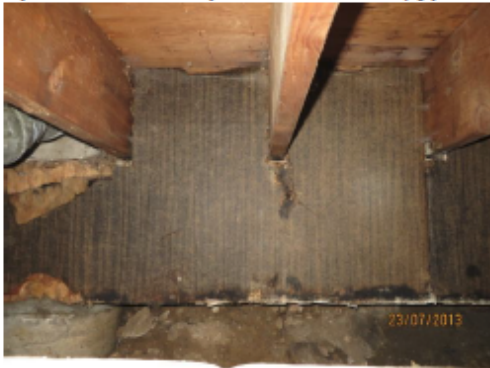
Undisturbed condition as discussed on previous page

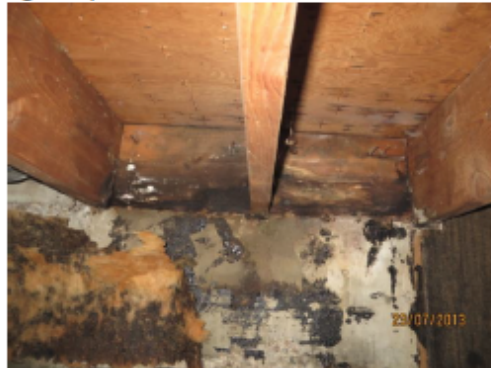
Perimeter with rigid fibreglass removed

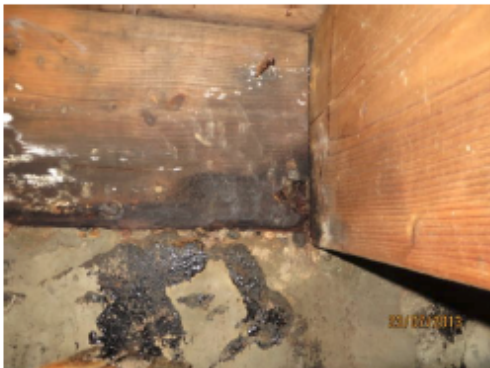
View of the left side of the central joist, note the white mycelia, and dark staining indicating fungal attack

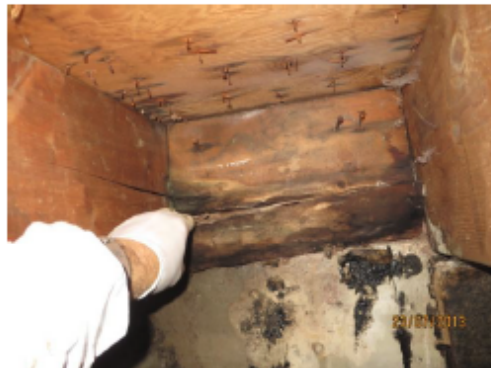
View of the right side of the central joist with a finger penetrating the rotten wood of the blocking

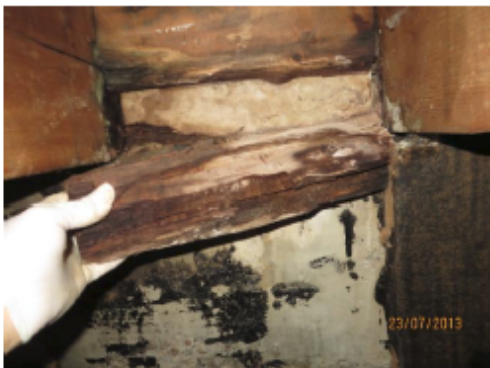
The rotten blocking was broken away by hand and was powdery with cuboidal cracking (Caused by fungi that have removed the cellulose from the wood and left the lignin, Sometimes referred to as 'Brown rot' or 'dry rot')

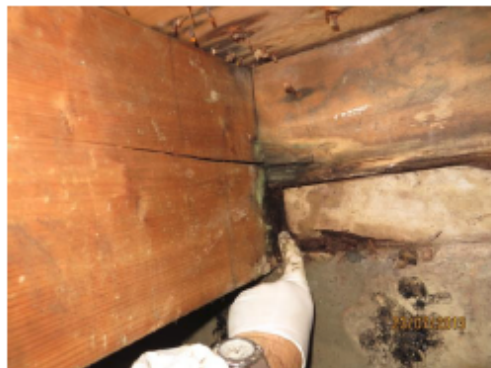
With the blocking removed it can be seen that the end of the joist has no structural integrity remaining

The crawlspace underneath the entire 1963 portion of the school is wet and has major water infiltration issues. The damp condition creates an environment conducive to the amplification of mould, which, when left unaddressed, results in rot, which in turn will compromise the structural integrity of the structure. At the current time, structural compromise has occurred and will continue to worsen unless the crawlspace environment is changed and the rotten lumber is replaced. The current impact that the crawlspace is having on the occupied areas above is manageable but can be expected to worsen and problems will amplify over the coming years unless full remediation is undertaken.

- Install temporary support beams to take the load off the affected exterior walls ( may require ability to raise the structure on jacks)
- Undertake mould and structural remediation (This will include the physical removal of rotten portions of the floor joists and will require an engineered design proposal for an acceptable method of repair. Repair will be complicated by the fact that the current system involves embedded joists at the grade beams)
